NATIONAL TRANSPORTATION SAFETY BOARD

MATERIALS LABORATORY FACTUAL REPORT

Report No. 18-041

Place : Peach Springs, Arizona
Date : February 10, 2018
Vehicle : Airbus Helicopter (Eurocopter) EC-130 B4, N155GC
NTSB No. : WPR18MA087
Investigator : Chihoon Shin (AS-40)

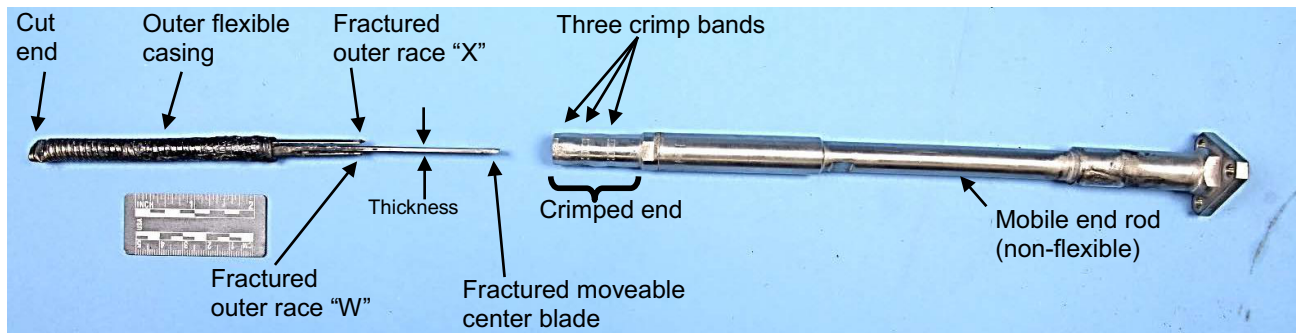
Figure 1 shows a photograph of the as-received Fenestron control cable. Figure 2 shows the cross section of the control cable. Figure 3 show close-up photographs of the fractured ends of the moveable center blade, ball cages, and outer races. Connection between the mobile end rod and the center blade is accomplished by means of a crimping process. The end of the center blade was manufactured with a reduced width portion. The reduced width portion of the center blade is to be inserted into the open end of the mobile end rod and, in turn, the outer surface of the rod end is to be crimped so that the reduced width portion of the center blade is retained inside of the mobile end rod.

Figure 1. Photograph of the as-received Fenestron control cable.

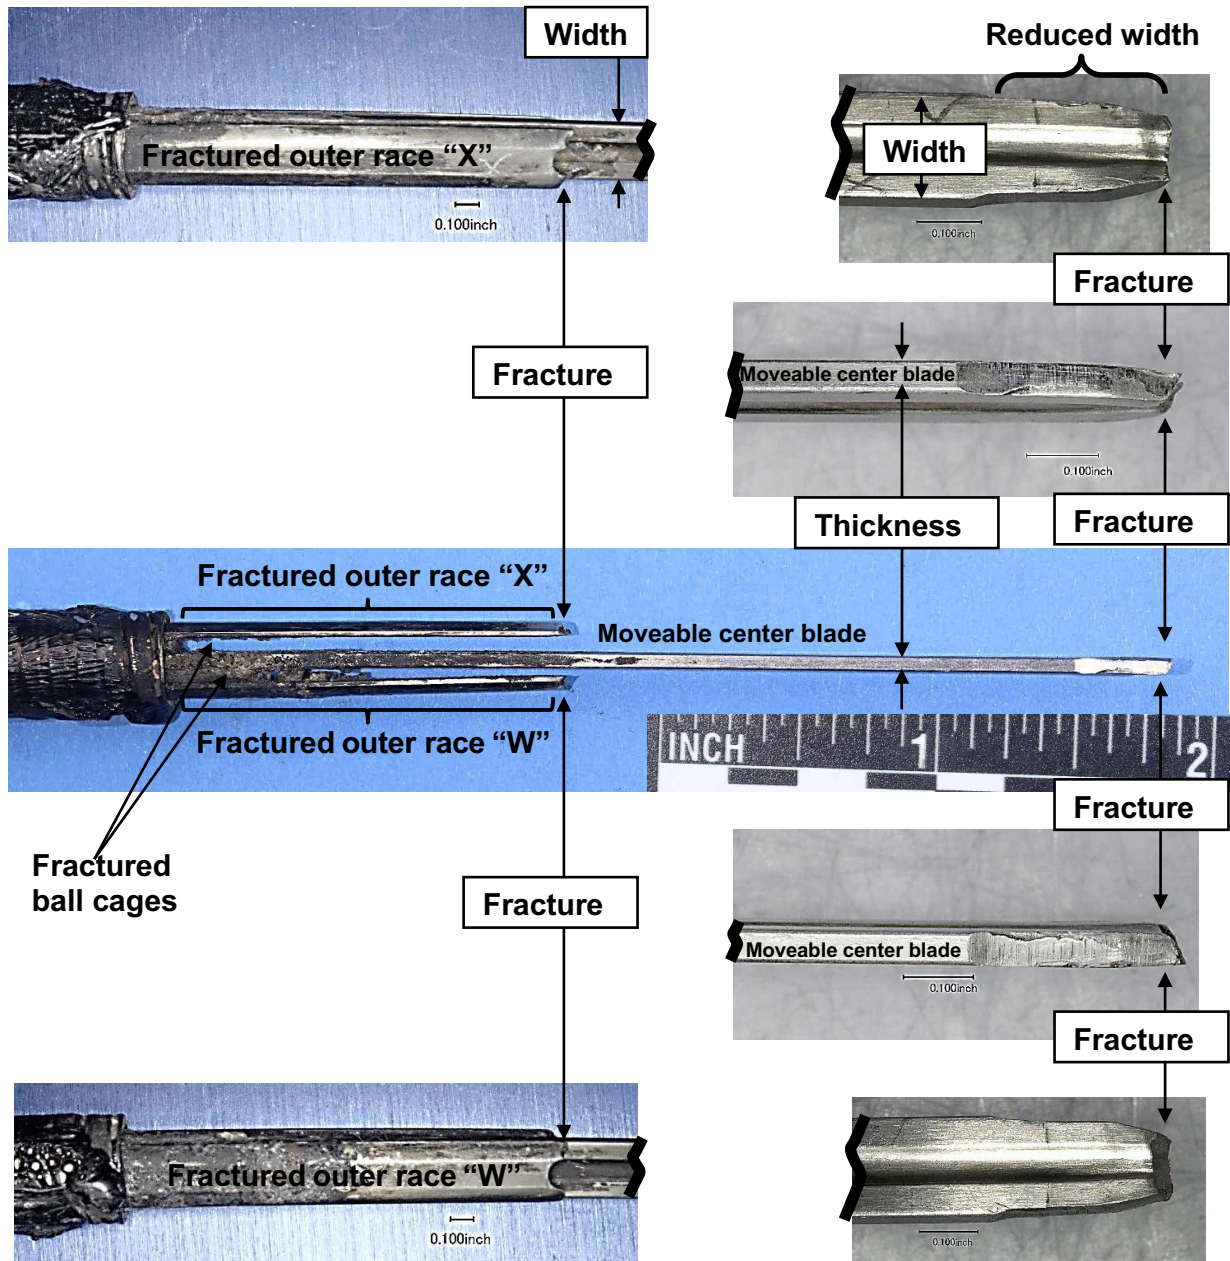
Bench binocular microscope examination of the control cable revealed the fracture face of the center blade was on a slant plane relative to the length of the blade. For the purpose of this examination, the outer cages were arbitrarily labeled "X" and "W", to identify the orientation of the parts relative to each other. Each outer cage contained a fracture that intersected a round slot for a ball. The ball cages are to be manufactured from Teflon. The exposed portions of the ball cages had fractured into multiple pieces. The outer flexible casing is to be made from Rilsan, a tradename used to describe a

The center blade and outer races were saw-cut in the areas near to their respective fracture faces, to facilitate examination of the fracture faces. The fracture faces were ultrasonic cleaned with acetone. Scanning electron microscope examination of the fractured center blade and outer races revealed the fracture faces contained micro-void coalescence fracture features consistent with ductile overstress separation, with no evidence of a pre-existing crack (such as a fatigue crack). Figure 4 shows an EDS spectrum from the center blade. The EDS spectrum contained a major elemental peak of iron, and minor elemental peaks of chromium, nickel, molybdenum, silicon, manganese, and carbon, consistent with a stainless steel alloy. The EDS spectra from the outer races were similar to that from the center blade.

Figure 3. Various views of the fractured moveable center blade and outer races "X" and "W".

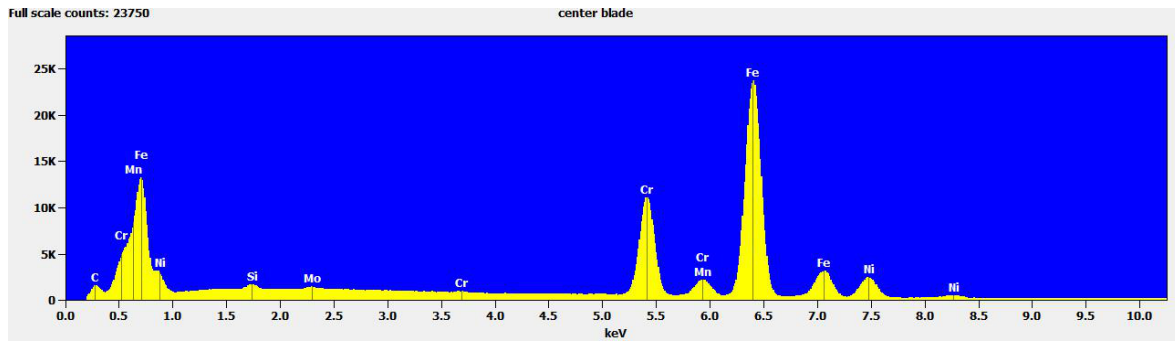
Figure 4. EDS spectrum of the center blade.
